CONFIDENTIAL	25 <b>X</b> 1
	(c) NATIONAL PHOTOGRAPHIC INTERPRETATION CENTER	
REFI	ERENCE: TROJAN HORSE  ATTACHMENT TO K-8153 4 MAY 1966 PAGE 1	25X1 25X1
	RECONSTRUCTION ACTIVITY BAN HOUEI SANE AIRFIELD, LAOS 1636N 10633E	25X1

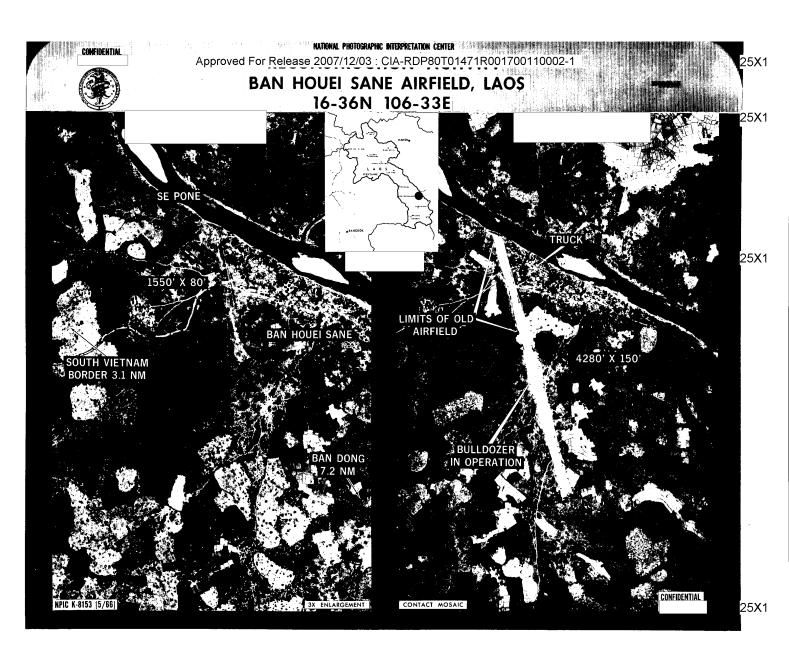
1.	SIGNIFICANCE:	
	THIS BRIEFING BOARD DEPICTS THE REGRADING AND EXTENSION OF THE	
	RUNWAY AT BAN HOUEI SANE AIRFIELD, LAOS.	
2.	LOCATION:	
	BAN HOUEI SANE AIRFIELD IS LOCATED ON THE NORTHEAST EDGE OF BAN	
	HOUEI SANE, 7.2 NM FROM BAN DONG, APPROXIMATELY 3.1 NM FROM THE SOUTH	
	VIETNAM BORDER.	
3•	MISSION READOUT:

A. TROJAN HORSE REVEALS BAN HOUEI SANE	25 <b>X</b> 1
	AIRFIELD TO CONSIST OF A 1550 X 80 FT, EAST/WEST RUNWAY.	
	B. REVEALS THAT THE RUNWAY OF	25 <b>X</b> 1
	BAN HOUEI SANE AIRFIELD IS BEING REGRADED AND EXTENDED. THE RUNWAY, IN	
	LATE STAGES OF CONSTRUCTION AND CURRENTLY UNSERVICEABLE, WILL, WHEN	
	COMPLETED, MEASURE APPROXIMATELY 4280 X 150 FT. THE FINAL SURFACING	
	MATERIAL CANNOT BE DETERMINED AT THIS TIME. ONE BULLDOZER IS OBSERVED	
	IN OPERATION ON THE RUNWAY AND ONE TRUCK IS NOTED WITHIN BAN HOUEI SANE	
	COMPLEX. ONE UNIDENTIFIED DERELICT AIRCRAFT IS OBSERVED AT THE AIRFIELD.	
	TROJAN HORSE	25 <b>X</b> 1
,		25 <b>X</b> 1
	These notes have been prepared for briefing purposes only and should not be used for detailed analytical work. Their use should be restricted to the particular briefing board(s) they were prepared for and must be considered valid only for the reporting period as indicated by the date of issue. For information concerning these notes contact Chief, Collateral Support Division, NPIC.
